# Errata

## **MSP430F47197 Microcontroller**

This document describes the known exceptions to the functional specifications (advisories).

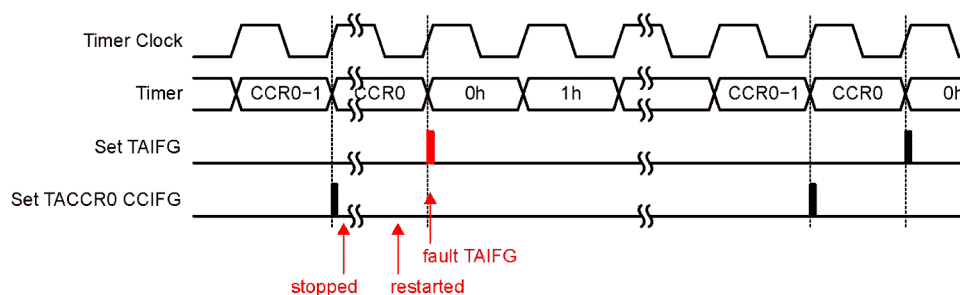
## TA21 *TA Module*

**Function** TAIFG Flag is erroneously set after Timer A restarts in Up Mode

**Description** In Up Mode, the TAIFG flag should only be set when the timer counts from TACCR0 to zero. However, if the Timer A is stopped at TAR = TACCR0, then cleared (TAR=0) by setting the TACLRL bit, and finally restarted in Up Mode, the next rising edge of the TACLK will erroneously set the TAIFG flag.

**Workaround** None.
