Errata

MSP430FG477 Microcontroller

This document describes the known exceptions to the functional specifications (advisories).

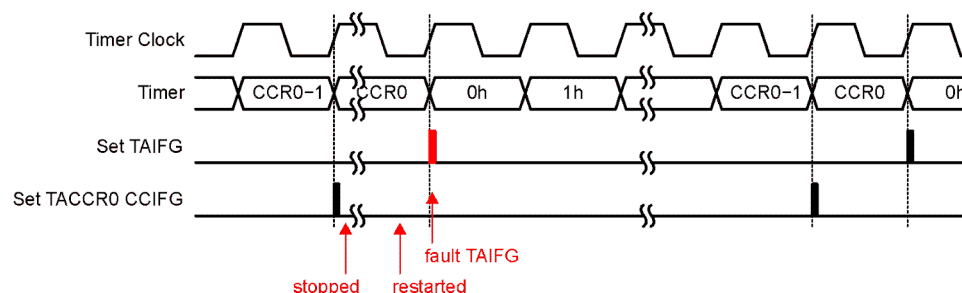
TA21 *TA Module*

| Function | TAIFG Flag is erroneously set after Timer A restarts in Up Mode |
| Description | In Up Mode, the TAIFG flag should only be set when the timer counts from TACCR0 to zero. However, if the Timer A is stopped at $TAR = TACCR0$, then cleared ($TAR=0$) by setting the TACLR bit, and finally restarted in Up Mode, the next rising edge of the TACLK will erroneously set the TAIFG flag. |

| Workaround | None. |

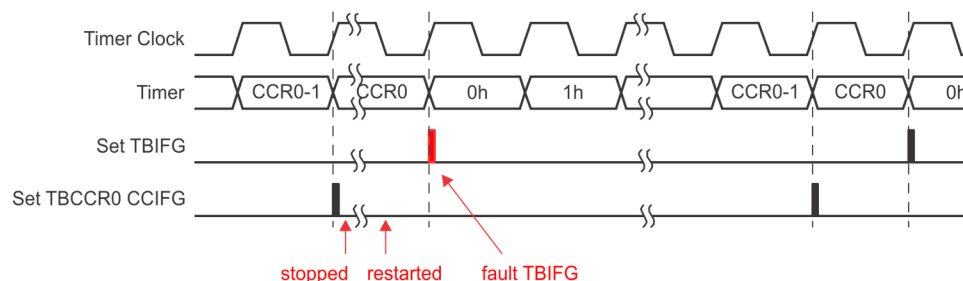
TB24

TBIFG Flag is erroneously set after Timer B restarts in Up Mode

In Up Mode, the TBIFG flag should only be set when the timer resets from TBCCR₀ to zero. However, if the Timer B is stopped at TBR = TBCCR₀, then cleared (TBR=0) by setting the TBCLR bit, and finally restarted in Up Mode, the next rising edge of the TBCLK will erroneously set the TBIFG flag.

Workaround None.
