# ***AM572x Sitara™ Processors Silicon Revisions 1.1, 2.0***

## ***Errata***

Literature Number: SPRZ429N  
JULY 2014 – REVISED JULY 2024

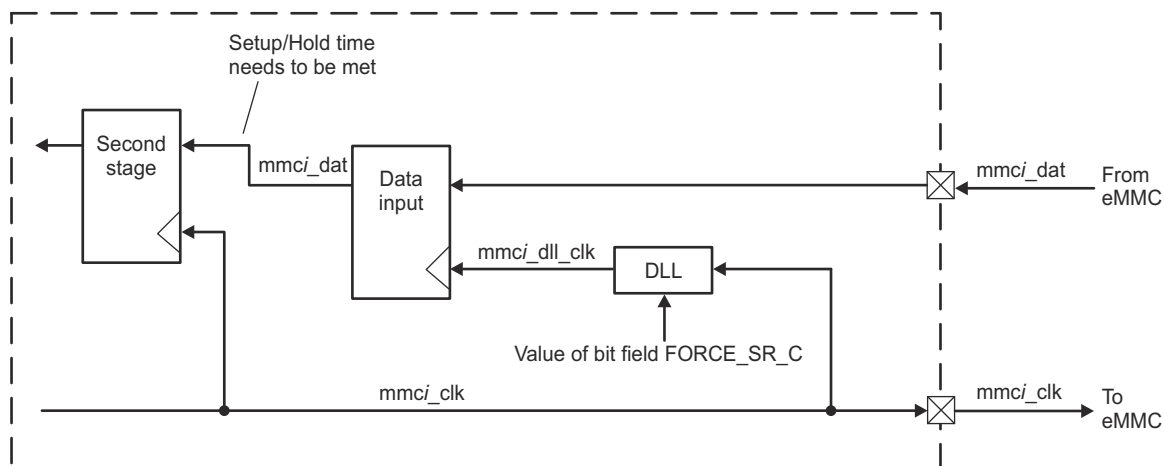
**Figure 2-2. Simplified SoC 192-MHz Mode DLL Block Diagram**

Internal to the MMC module, a second stage latch is used to recapture data captured by DLL delayed CLK, MMC\_DLL\_CLK. The second stage latch captures with the original transmitting clock, MMC\_CLK.

MMC\_DLL\_CLK and MMC\_CLK both run at the same clock frequency. This results in a narrow range of tuning ratio elements, where the delayed MMC\_DLL\_CLK comes in phase with MMC\_CLK. If the clocks are in phase, the data captured by the first clock violates the setup and hold time requirements needed for the second stage latch, resulting in incorrectly read data. This is known as tuning re-timing errors.

A DLL tuning algorithm has been implemented that can avoid the tuning re-timing errors. More details on this can be found in App Note [SPRACA9](#). The following notes summarize the updated algorithm:
