Errata

AM65x Processors

Silicon Revision 2.1, 2.0, 1.0

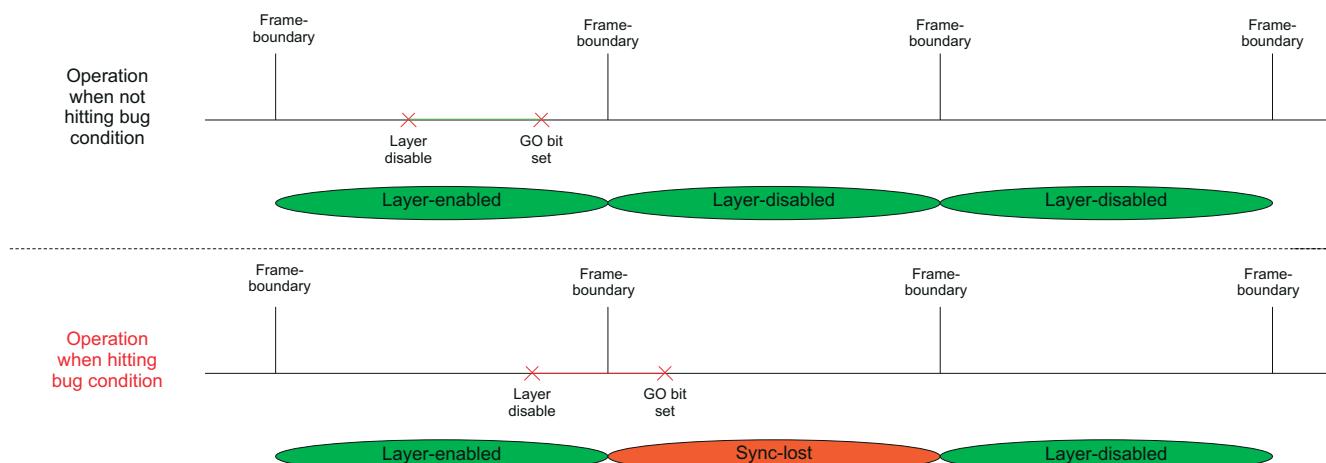
Figure 3-1. Bug Condition

i2097
DSS: Disabling a Layer Connected to Overlay May Result in Synclost During the Next Frame
Details:

Disabling a layer (for example VID1) connected to an OVR (that is toggling DSS_VID_ATTRIBUTESx[0] ENABLE from 1 to 0) may result in synclost during the next frame. The synclost may result in a corrupted or blank frame (all pixel data sent out of DSS during the frame is 0x0). The occurrence of synclost is dependent on the timing of setting the GO bit (that is DSS_VP_CONTROL[5] GOBIT to 1) vis-à-vis the disabling of the layer. If the “disable layer” MMR write operation and “set GO bit” MMR write operation happens within the same frame boundary, no synclost occurs. If the operations happen across the frame boundary, then synclost occurs (for one frame). The design automatically recovers and returns to normal operation from the next frame after GO bit is set, see [Figure 3-1](#).

A sample software workaround pseudo-code is shown on [Figure 3-2](#). In this case, the regular “disable layer” MMR write operation and “set GO bit set” MMR write operation are replaced with macros which implement the software workaround.

- Replace layer disable MMR write operation with a macro which positions the layer to the non-visible area of the OVR
- Track which layers are disabled. This will be used while GO bit is set

- Replace GO bit set MMR write operation with this macro
- First, set GO Bit for the changes in "disable_layer" macro (and any other earlier changes) to take effect
- After the first GO bit set, few idle_cycles (10 DSS functional clock cycles) are necessary before we move to the second step

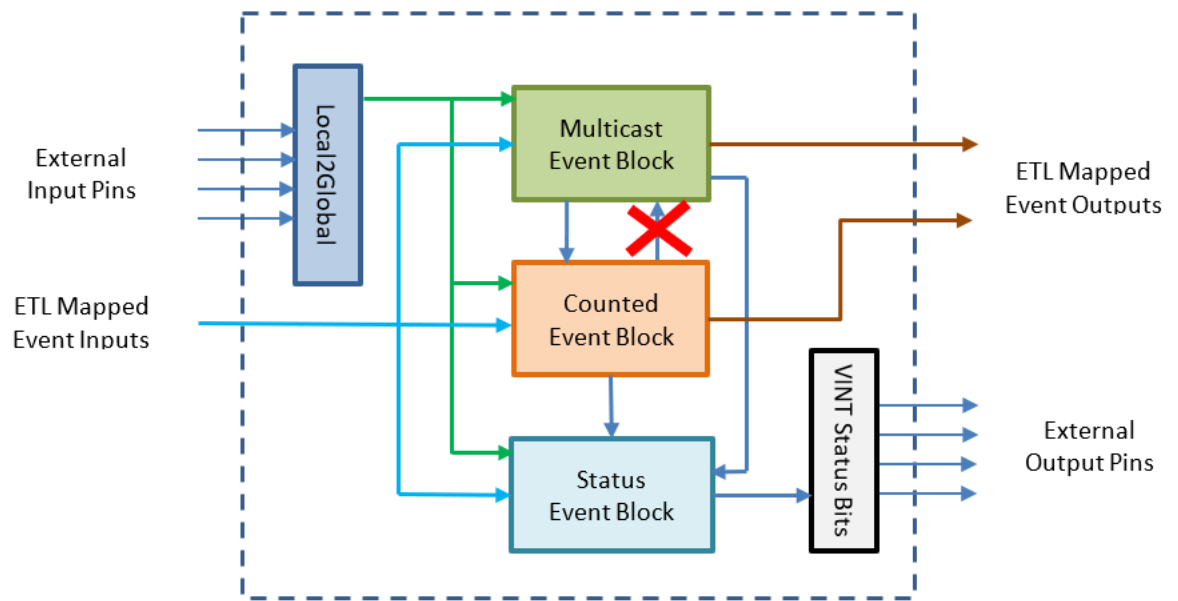
Figure 3-3. Interrupt Aggregator Version 1.0

An issue was found after design that could cause the IA to deadlock. The issue occurs when event "loops" occur between these three processing blocks. It is possible to create a situation where a processing block can not output an event because the path is blocked, and since it can not output an event, it can not take any new input events. This inability to take input events prevents the output path from being able to unwind, and thus both paths remain blocked.

IA: Potential deadlock scenarios in IA

By following the conventions outlined here, the system is safe from looping hazards that can create a deadlock scenario.

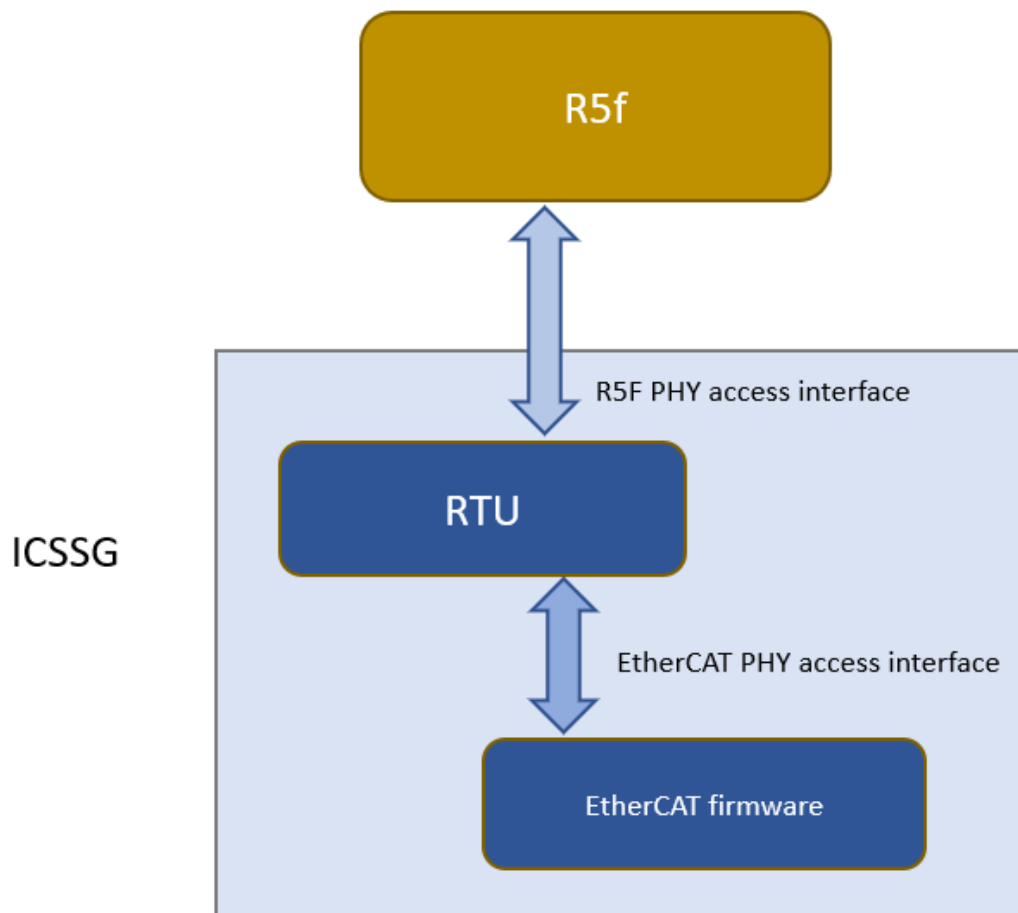
**Figure 3-4. MDIO Emulation via Manual Mode using PRU Core**

MDIO: MDIO interface corruption (CPSW and PRU-ICSS)
