Errata

MSP430F67781 Microcontroller

ABSTRACT

This document describes the known exceptions to the functional specifications (advisories).

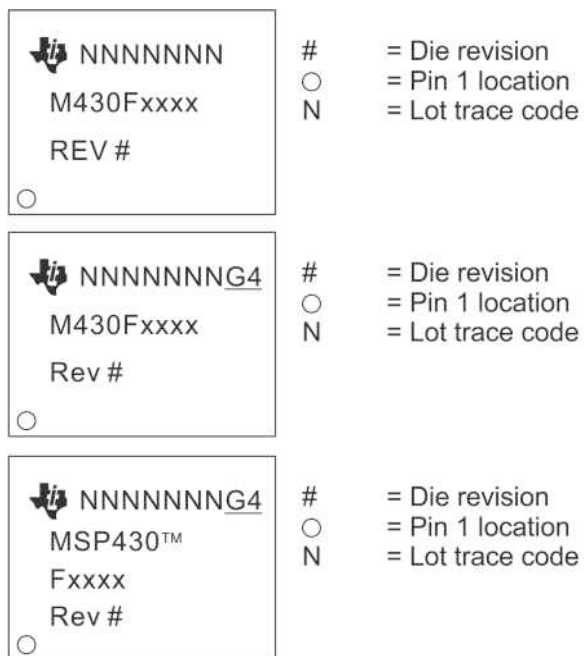
PZ100

LQFP (PZ) 100 Pin

NOTE: Package marking with "TM" applies only to devices released after 2011.
