Errata

MSP430F5237 Microcontroller

This document describes the known exceptions to the functional specifications (advisories).

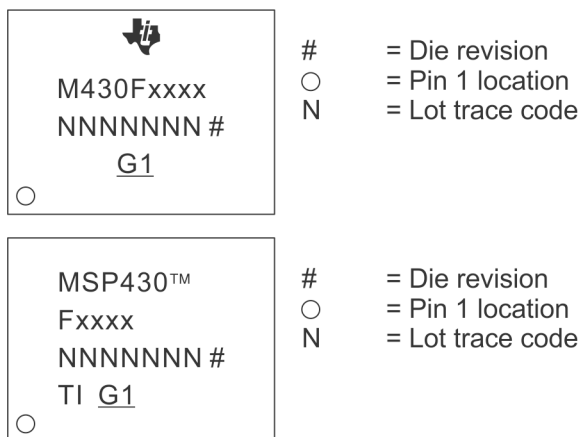
ZQE80

BGA (ZQE), 80 pin

NOTE: Package marking with "TM" applies only to devices released after 2011.

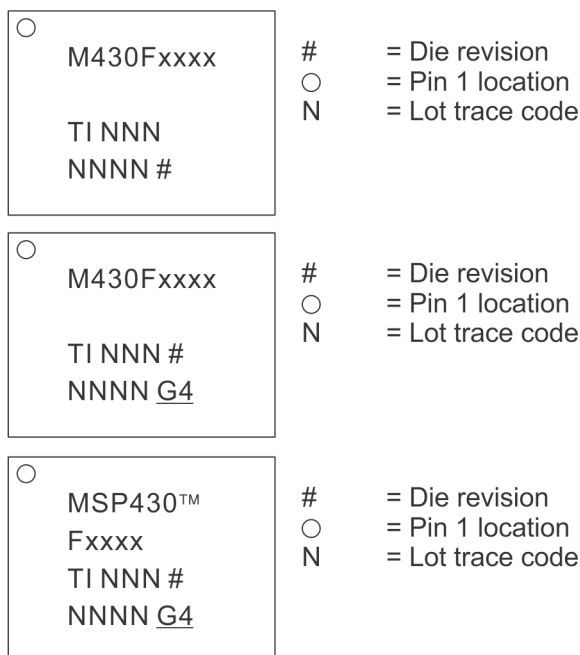
RGC64

QFN (RGC), 64 pin

NOTE: Package marking with "TM" applies only to devices released after 2011.
